2017 ASPECT Preliminary Report Rapids Needs Assessment

September 4, 2017 0600 hrs to 1900 hrs

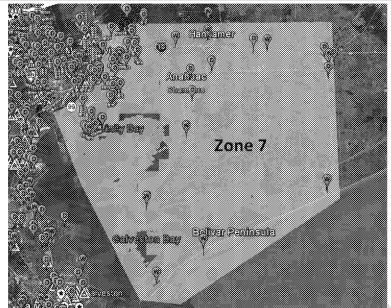
Figure 2: Google Earth image showing Zone 7 (Chambers County) Rapid Needs Assessment targets (>15 remaining targets, 15 flight lines). "D" represents drinking water facilities, "W" represents wastewater treatment facilities, and yellow triangle represent risk management plan sites, and a black star in a yellow balloon represent National Priority List sites. Every photo will be geo-corrected and validated by the reachback team and then made available on the ASPECT "n-link" file. The validation process will delay the distribution/access to these files for at least one day.

0945 hrs: ASPECT arrives on station in Zone 7 to photo and survey the remaining targets (>15 targets, 15 flight lines).

1030 hrs: ASPECT completes the remaining RNA surveys in Zone 7 and had no chemical detections. The crew heads to Hobby Airfield to refuel, upload data, and eat lunch.

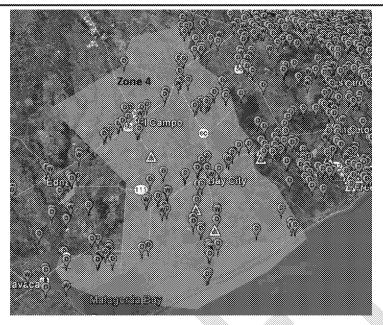
Figure 3: Google Earth image showing Zone 4 (Matagorda and Wharton Counties) Rapid Needs Assessment targets (>110 remaining targets, 85 flight lines). "D" represents drinking water facilities, "W" represents wastewater treatment facilities, and yellow triangle represent risk management plan sites, and a black star in a yellow balloon represent National Priority List sites. Every photo will be geo-corrected and validated by the reachback team and then made available on the ASPECT "n-link" file. The validation process will delay the distribution/access to these files for at least one day.

1220 hrs: ASPECT is airborne and en route to Matagorda and Wharton Counties (Zone 4) to photograph and survey RNA targets (about 110 targets; 85 flight lines). Figure 3 shows targets in Zone 4.

1620 hrs: ASPECT completes 51 of 85 flight lines in Zone 4 (Matagorda County) and lands at Hobby Airfield. Figure 4 shows a typical geo-corrected aerial image from the RNA mission. Data from this flight are being processed and results should be available tomorrow.

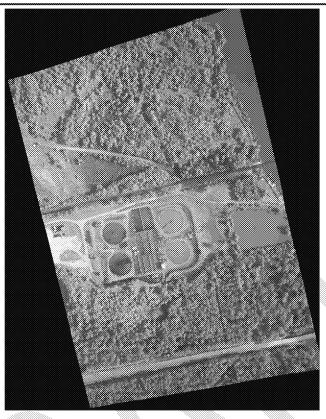
Figure 4: Example geo-corrected photograph from the RNA mission. These are validated by the reachback team and then made available through the Google Earth ASPECT n-link file.
